DEPARTMENT OF TRANSPORTATION

Quality Assurance and Source Inspection

Contract #: 04-0120F4Cty: SF/ALA Rte: 80 PM: 13.2/13.9File #: 99.28**WELDING INSPECTION REPORT****Resident Engineer:** Casey, William**Address:** 333 Burma Road**City:** Oakland, CA 94607**Report No:** WIR-026545**Date Inspected:** 17-Oct-2011**Project Name:** SAS Superstructure**OSM Arrival Time:** 600**Prime Contractor:** American Bridge/Fluor Enterprises, a JV**OSM Departure Time:** 1630**Contractor:** American Bridge/Fluor Enterprises, a JV**Location:** Job Site**CWI Name:** See Below**CWI Present:** Yes No**Inspected CWI report:** Yes No N/A**Rod Oven in Use:** Yes No N/A**Electrode to specification:** Yes No N/A**Weld Procedures Followed:** Yes No N/A**Qualified Welders:** Yes No N/A**Verified Joint Fit-up:** Yes No N/A**Approved Drawings:** Yes No N/A**Approved WPS:** Yes No N/A**Delayed / Cancelled:** Yes No N/A**Bridge No:** 34-0006**Component:** OBG and Tower**Summary of Items Observed:**

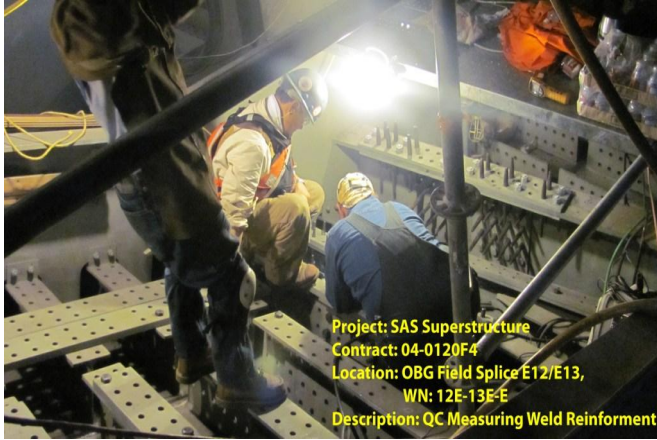
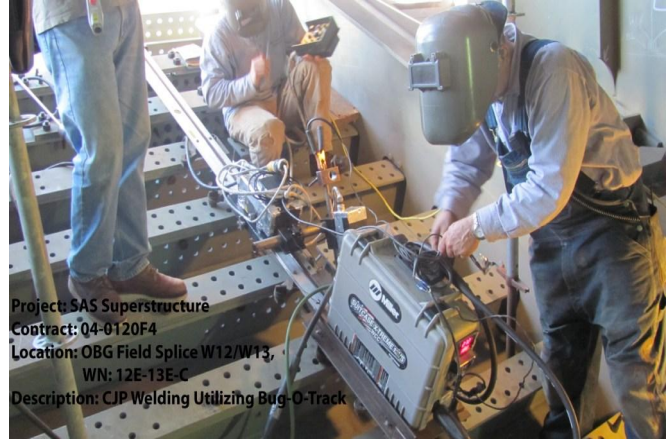
The the digital photographs on page 4 of this report illustrate some of the activities observed during this shift.
